Re: Monthly Report Summary #16 for Aliso Canyon Turbine Replacement Project

Aliso Canyon Turbine Replacement Project CPUC Site Inspection Form

Project:	Aliso Canyon Turbine Replacement	Date:	July 2, 2015
Project Proponent:	Southern California Gas Company and Southern California Edison	Report #:	VS061
Lead Agency:	California Public Utilities Commission	Monitor(s):	Vince Semonsen
CPUC PM:	Andrew Barnsdale, Energy Division	AM/PM Weather:	Calm, partly cloudy, warm and humid – 20% chance of thundershowers.
E & E CM:	Lara Rachowicz	Start/End time:	0700 - 1100 in Wiley Cyn. 1130 - 1330 at the Aliso Gas Storage Field.
Project NTP(s):	Guard House and Road Widening (NTP-1). The New Admin/IM Building (NTP-2) and Central Compressor Station (CCS) (NTP-3). P-41 Fill Site (NTP-2), PS-42 Fill Site, P-32 Fill Site (NTP-3), and the Natural Substation (NTP-A, NTP-D). TSPs 11 through 33 (NTPs A, C, and D) and the SCE 210 Freeway Yard.

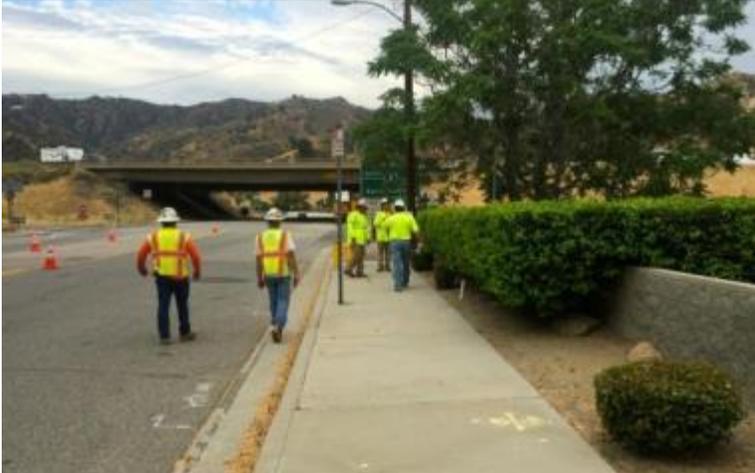
Date	Location	Photo	Description
7/02/15	TSP 11

<p>Crew is preparing to install temporary poles to prevent wires from falling onto the road.</p>
7/02/15	TSP 26

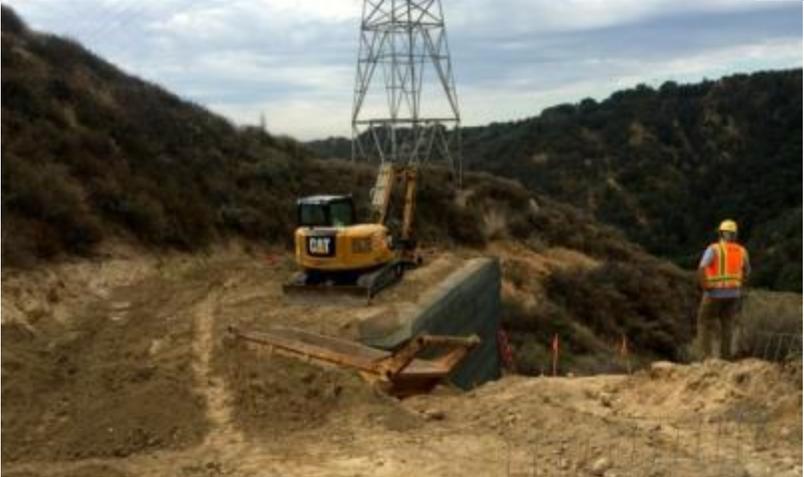
Equipment working on the Hillfiker wall next to the pole site.

At TSP 30 the Hillfiker wall had been finished and the foundation hole had been drilled – see photo. A crew was setting the rebar cage, with the concrete to be poured soon. The topsoil piled had been covered with jute netting.

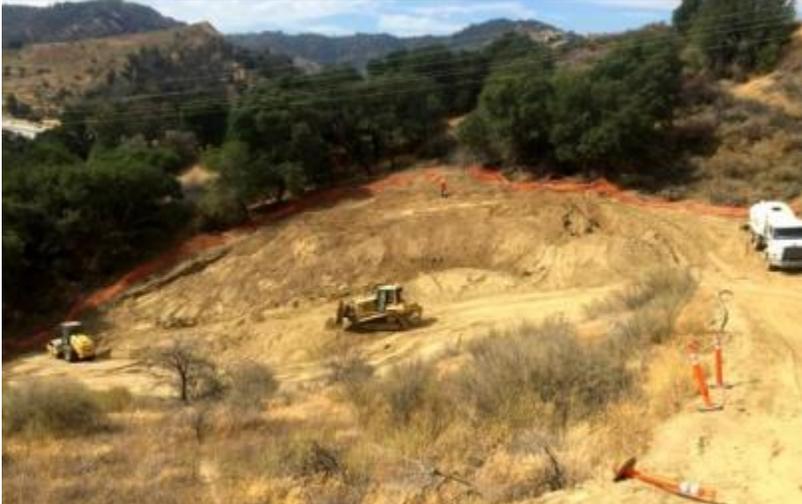
Date	Location	Photo	Description
7/02/15	TSP 21

Grading continues for the TSP 21 pull site.
7/02/15	TSP 21

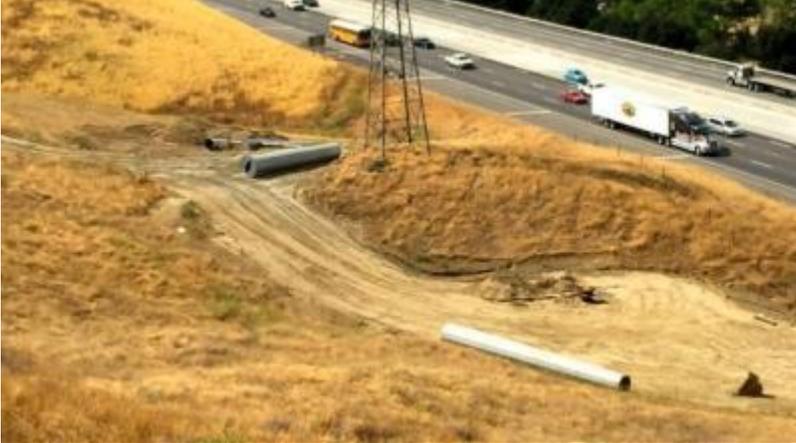
<p>Equipment and topsoil is being stockpiled at this site.</p>

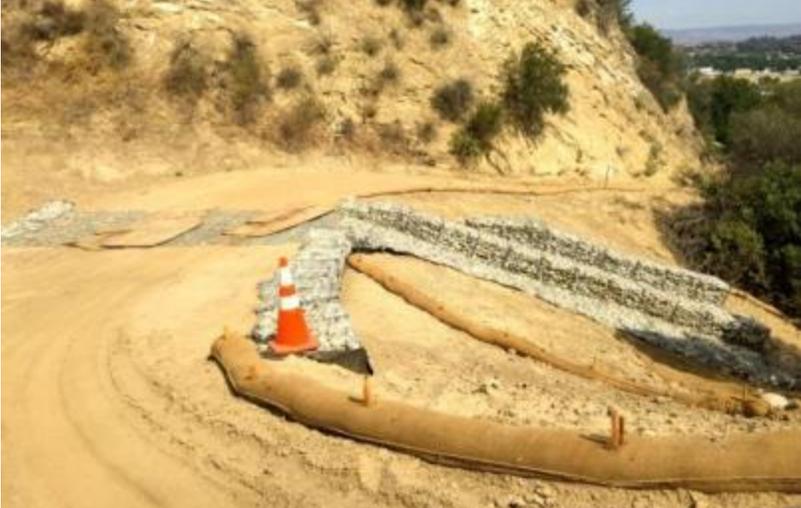
Road stabilization work has been completed.

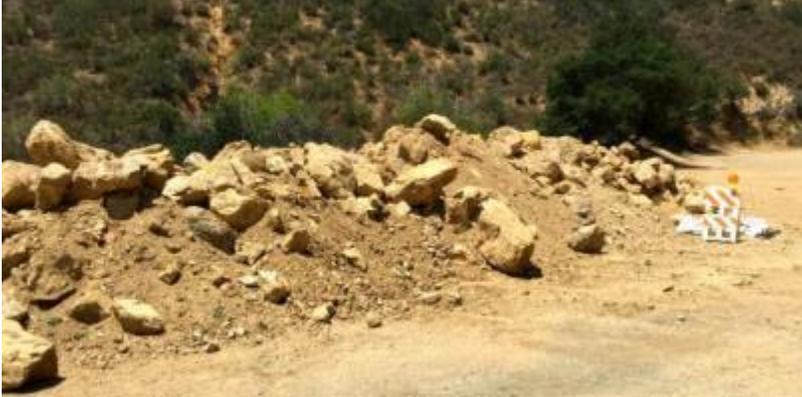
Stockpiled native rock to be used to stabilize the base of the fill site.

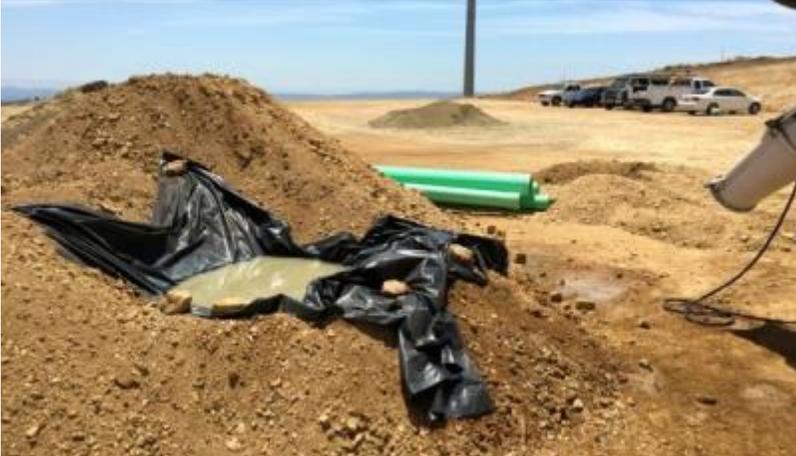
Date	Location	Photo	Description
7/02/15	Natural Substation

Concrete washout within the Natural Substation.
7/02/15	Natural Substation

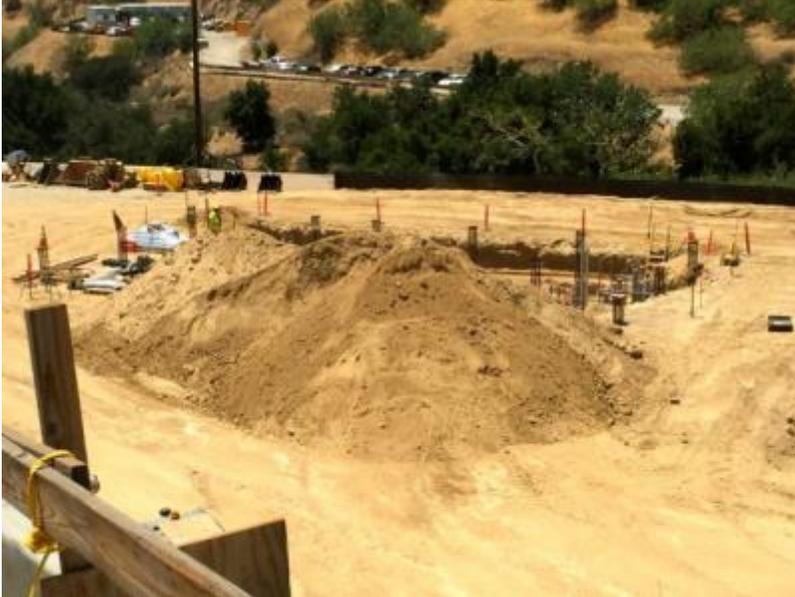
Date	Location	Photo	Description
7/02/15	CCS

A wide-angle photograph of a large-scale construction site. In the foreground, there is a large, conical pile of light-colored sand or soil. Behind it, several vertical rebar structures are visible, some with concrete caps. The background shows a dirt road, some greenery, and a hillside under a clear sky.	Excavated area with slurry being poured.
7/02/15	Guard House

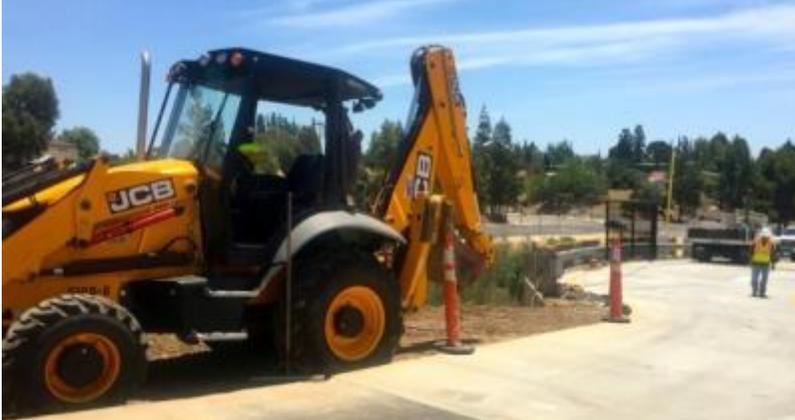
A photograph of a yellow JCB backhoe loader parked on a paved surface. The loader is facing left, and its rear-mounted backhoe arm is visible. In the background, there is a guard house structure, some trees, and a person standing near a vehicle. The sky is blue with some light clouds.	Minor excavation work is taking place at the Guard House.

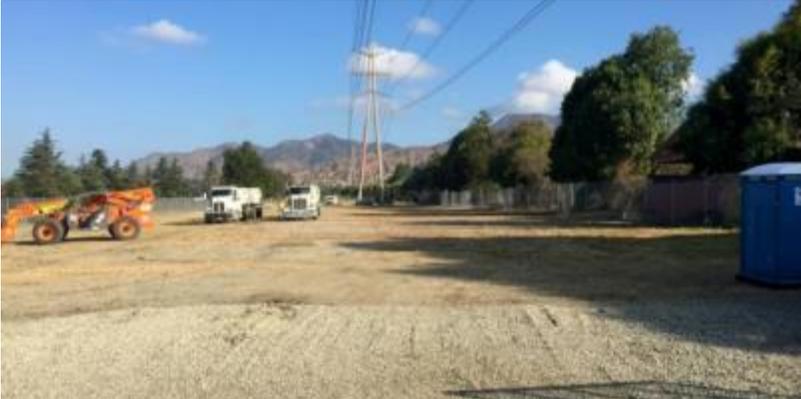
Date	Location	Photo	Description
7/10/15	SCE 210 Freeway Yard

The new expansion area for the 210 Freeway Yard.
7/10/15	TSP 11

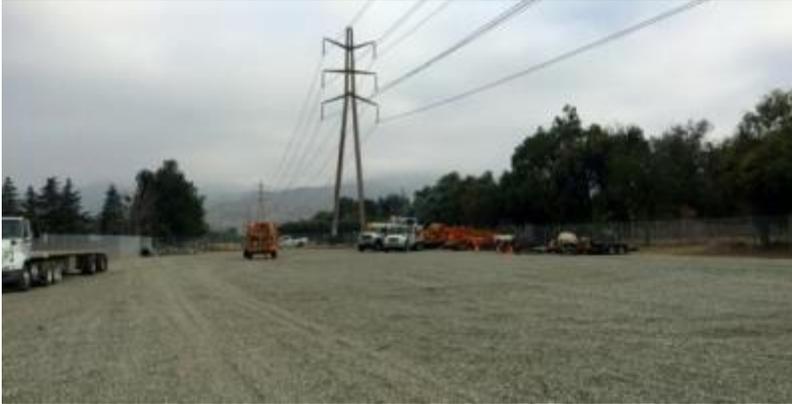
Date	Location	Photo	Description
7/15/15	SCE 210 Freeway Yard

SCE has cleared, fenced, and laid gravel in the expanded 210 Freeway Yard. SCE is now using the site – see photo. The piece of equipment (a bobcat) that burned during the June fire is stored in the yard – see photo.

<p>After being cleared, fenced, and having gravel laid down, the new expansion area is now being used.</p>
7/15/15	SCE 210 Freeway Yard

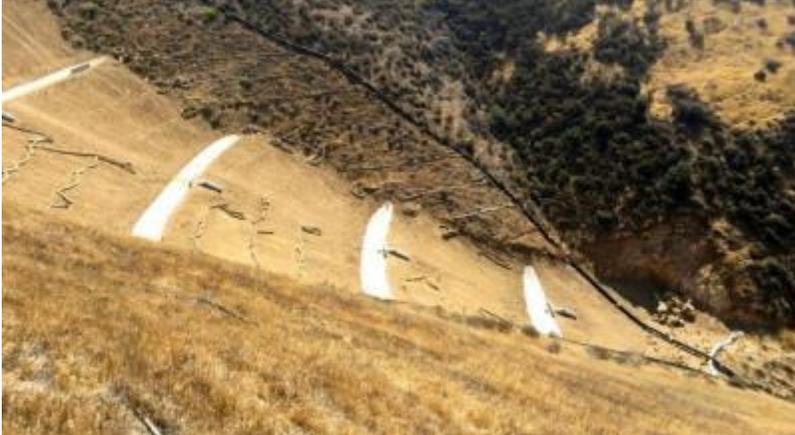
Date	Location	Photo	Description
7/15/15	PS-42 Fill Site

Fill slope with "V" ditches and BMP materials in place.
7/15/15	PS-42 Fill Site

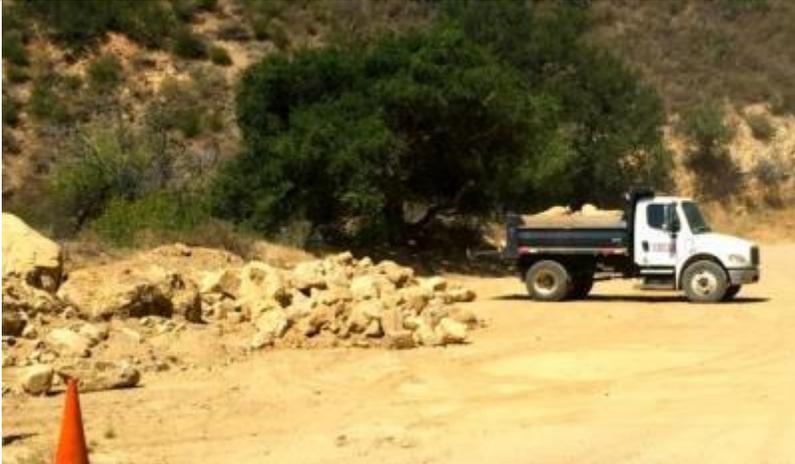
Rock is being brought to the well pad below the fill site in preparation for use at the site.

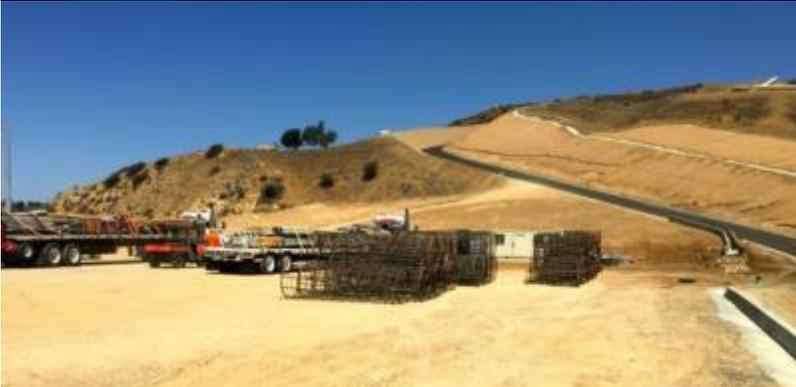
Materials are being brought in and stockpiled at the site.
7/15/15	Project overview

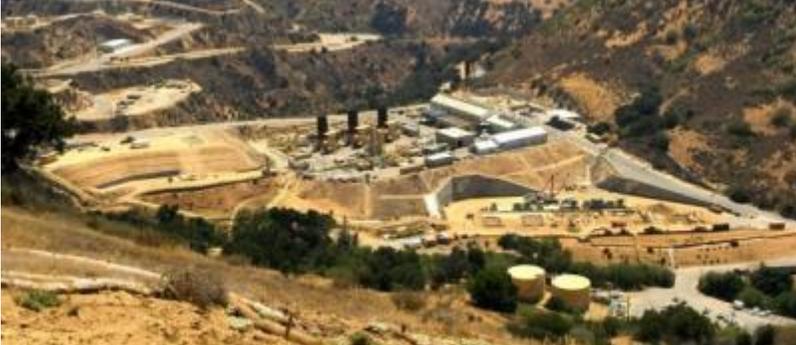
Project overview looking from the Natural Substation

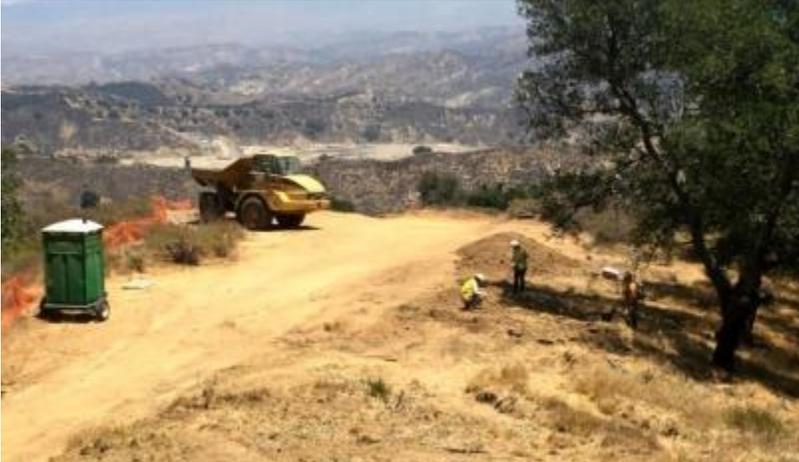
Date	Location	Photo	Description
7/15/15	Access road between TSP 40 and TSP 41

Biological monitoring crew is raking through the topsoil looking for Mariposa lily bulbs.
7/15/15	Access road between TSP 40 and TSP 41

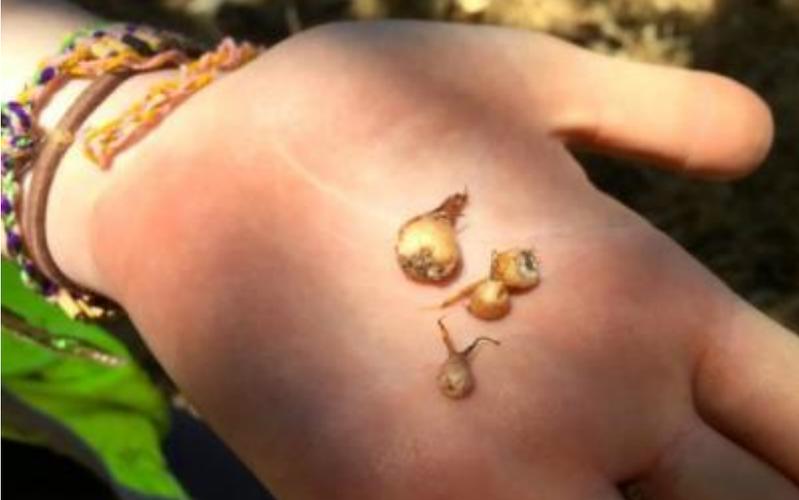
Mariposa lily bulbs.

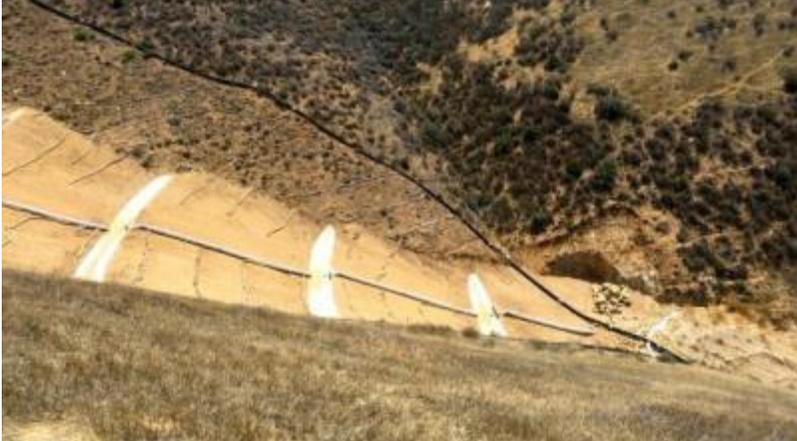
Date	Location	Photo	Description
7/23/15	PS-42 Fill Site

Middle portion of the fill slope with "V" ditches finished and drainpipes connected.
7/23/15	PS-42 Fill Site

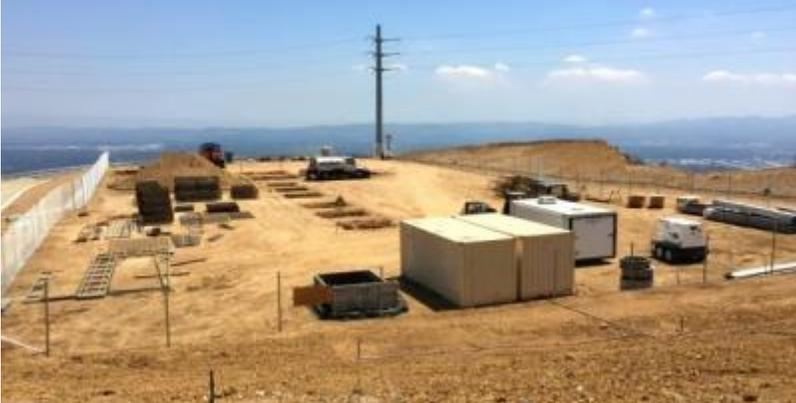
Materials continue to be brought in; some excavation has been completed.

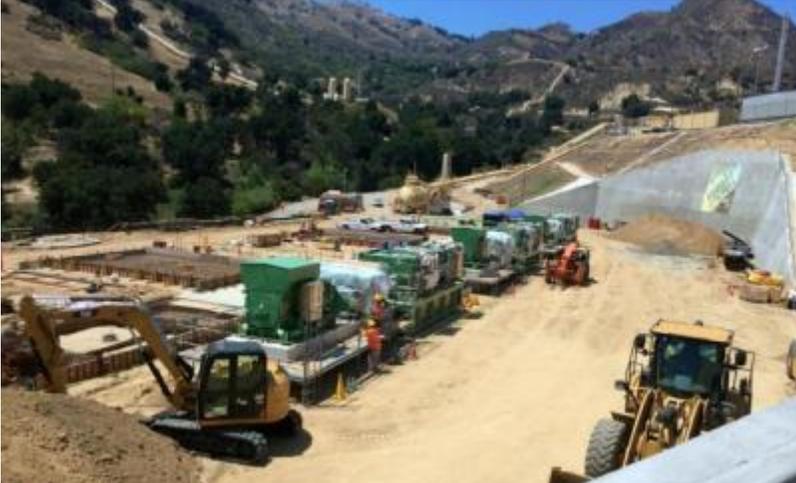
Date	Location	Photo	Description
7/23/15	CCS

Equipment is being worked on.
7/23/15	CCS

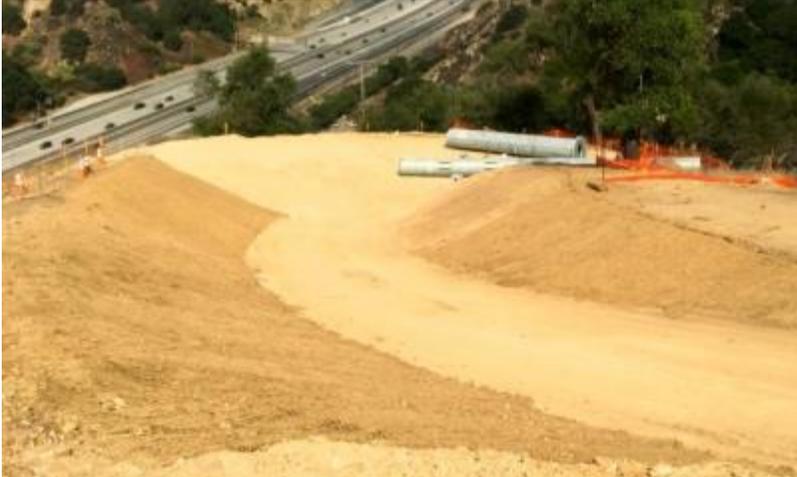
Date	Location	Photo	Description
7/30/15	TSP 32

Some additional jute netting has been installed, but the work has not been completed.
7/30/15	Access road to TSP 25

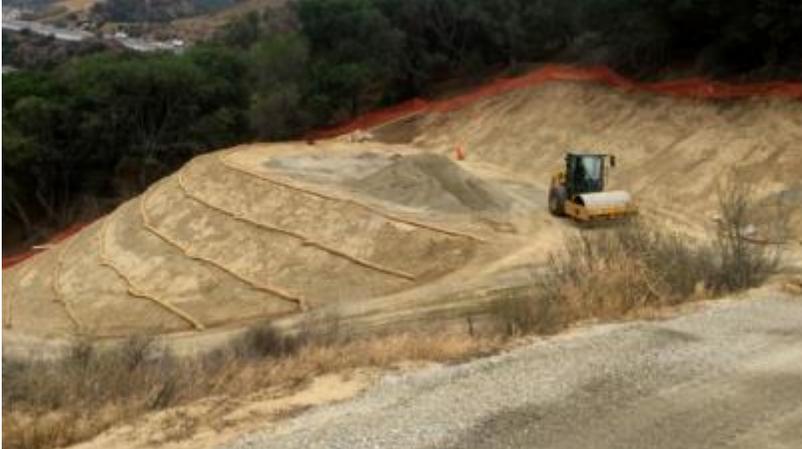
The location is being used to stockpile the road base that is being applied to the access road.

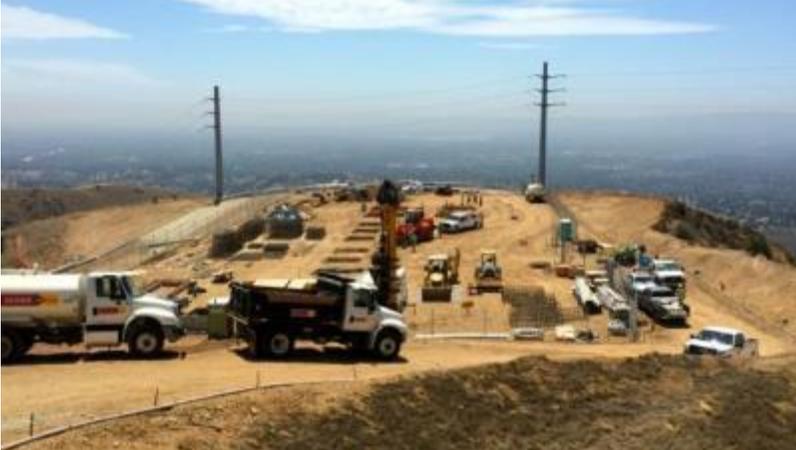
Materials continue to be transported to the site – some excavation has been completed.
