Garcia and Associates
2601 Mission Street, Suite 600
San Francisco, CA 94110
Phone: (415) 642-8969
Fax: (415) 642-8967

RE: Fulton-Fitch Reconductoring Project, Water Crossing Mapping

Appendix A. Fulton-Fitch Work Area and Crossing Photos

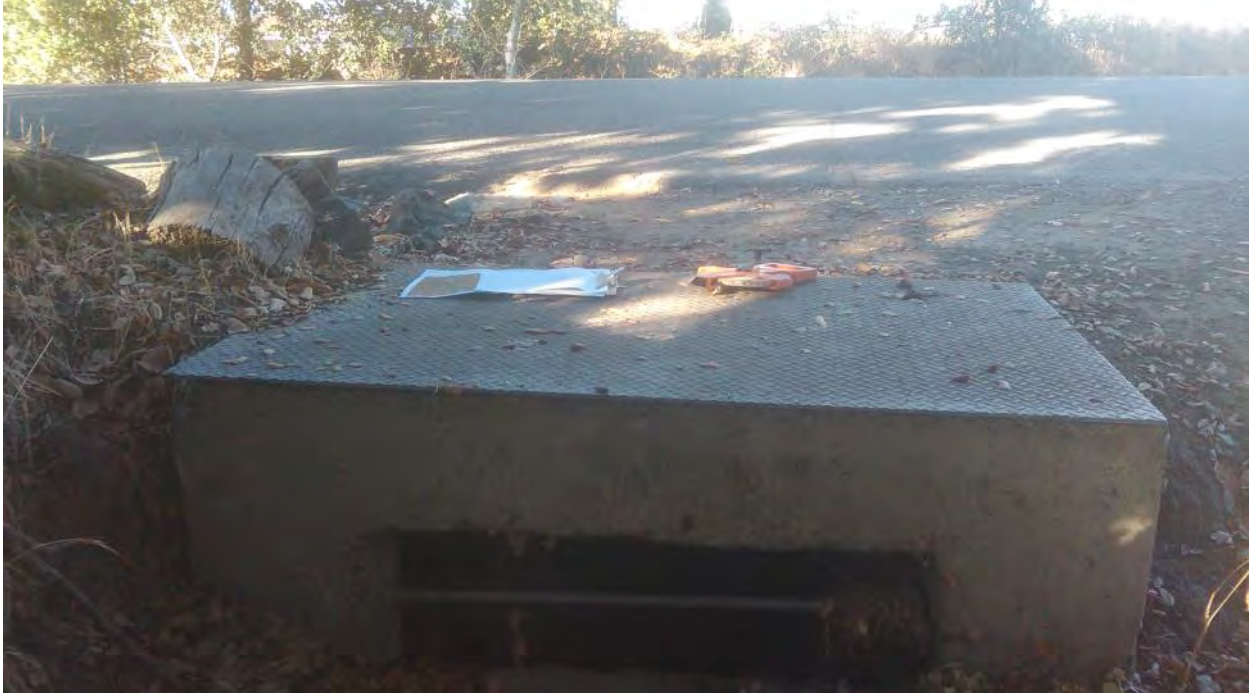
FFW1 – Pole 20; SEW41 Culvert at terminus of drainage (photo facing east)

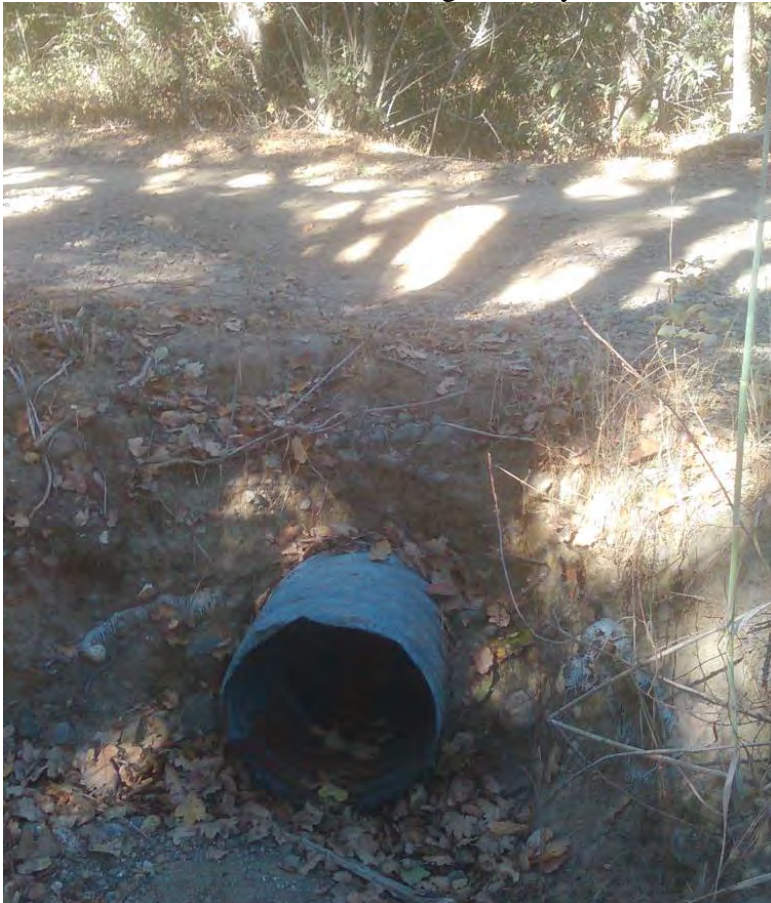
FFX12	4270976	516794	RIWO9	Riparian Woodland	3-6	5	Major access road between vineyards, crosses seasonal creek at this location	1.5ft diameter, 20ft length, corrugated steel pipe in good condition	Dispersal	No Action	No permitting required.

FFX12 – RIWO9; Culvert crossing on vineyard access road (photo facing west)

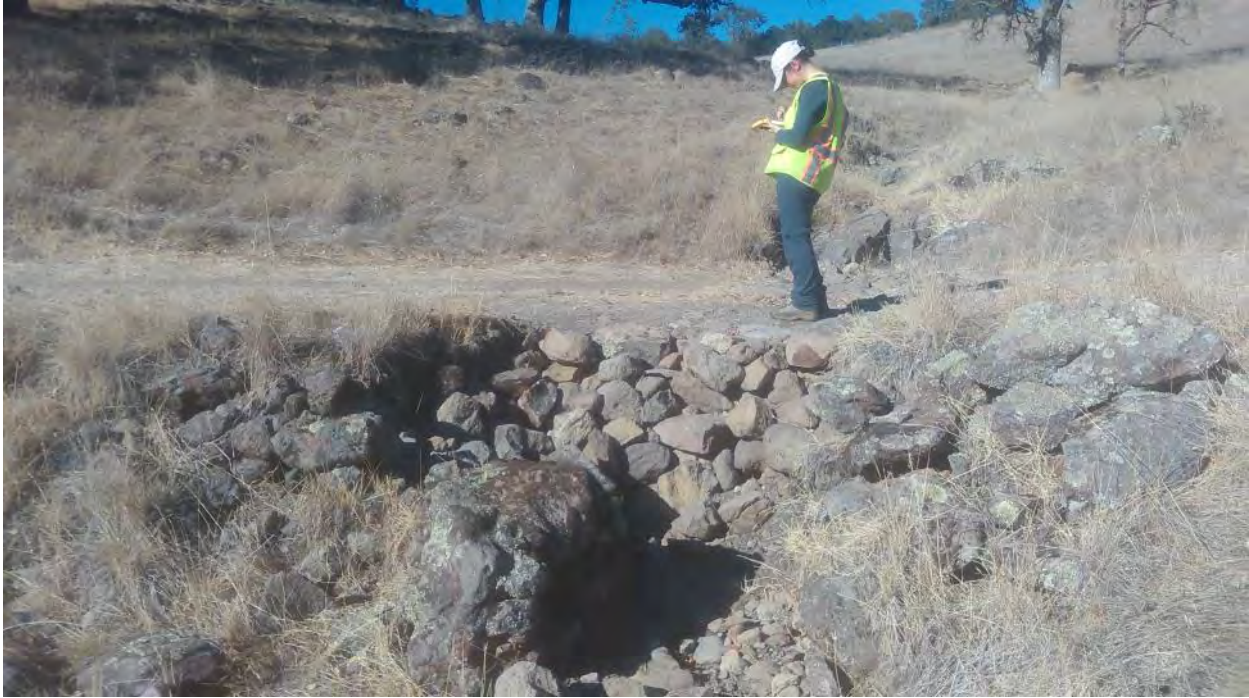
FFX20 – SEW6; Crossing point for seasonal watercourse (photo facing northeast)

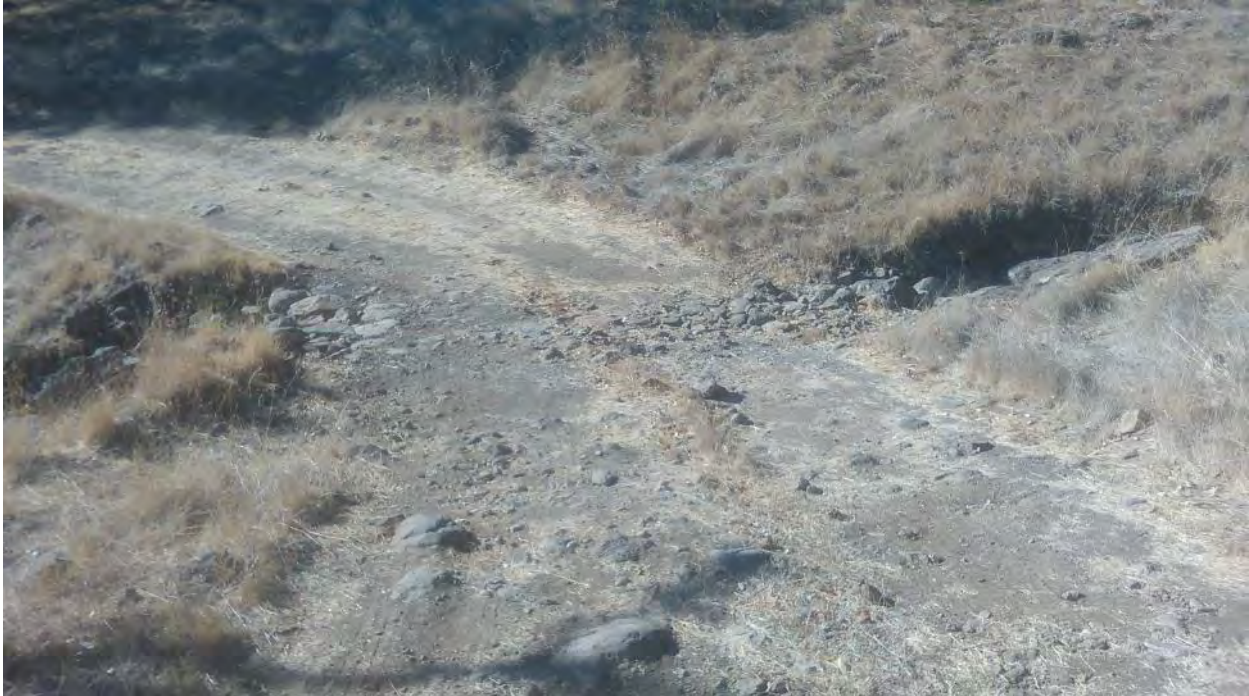
FFX20 – SEW6; Crossing point for seasonal watercourse (photo facing northwest)
