SOUTHERN CALIFORNIA EDISON
Preliminary Geology and Geotechnical Evaluation
Riverside Transmission Reliability Project (RTRP)
Double Circuit 230kV T/L
Eastern, Western and Van Buren Suggested Routes
Mira Loma - Vista #1 230kV to Wildlife Substation
Riverside County, California

June 10, 2010
Project # 10-037
Revision 1

Subject: Preliminary Geology and Geotechnical Evaluation
Riverside Transmission Reliability Project (RTRP)
Double Circuit 230 kV T/L
Eastern, Western and Van Buren Suggested Routes
Mira Loma - Vista #1 230 kV to Wildlife Substation
Riverside County, California

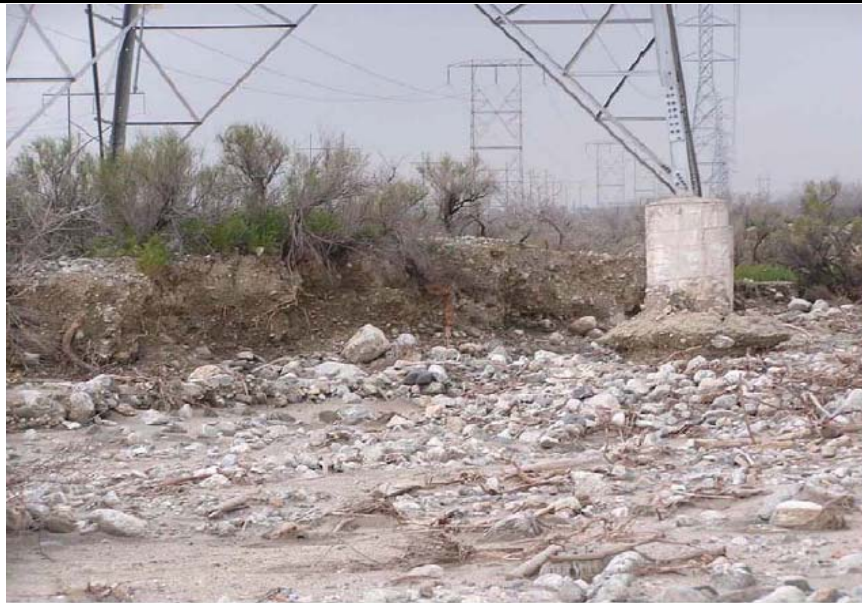
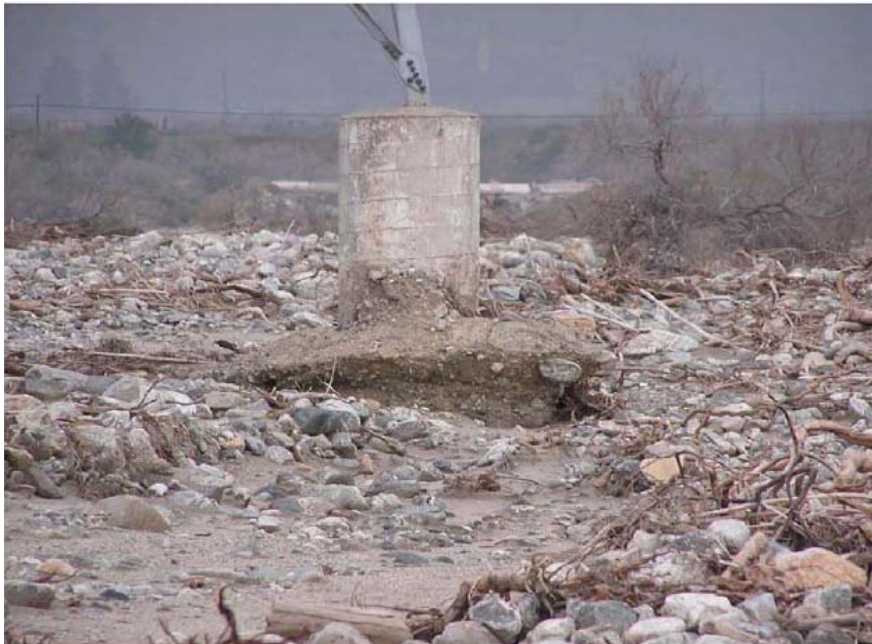
15

Banning

Erosion

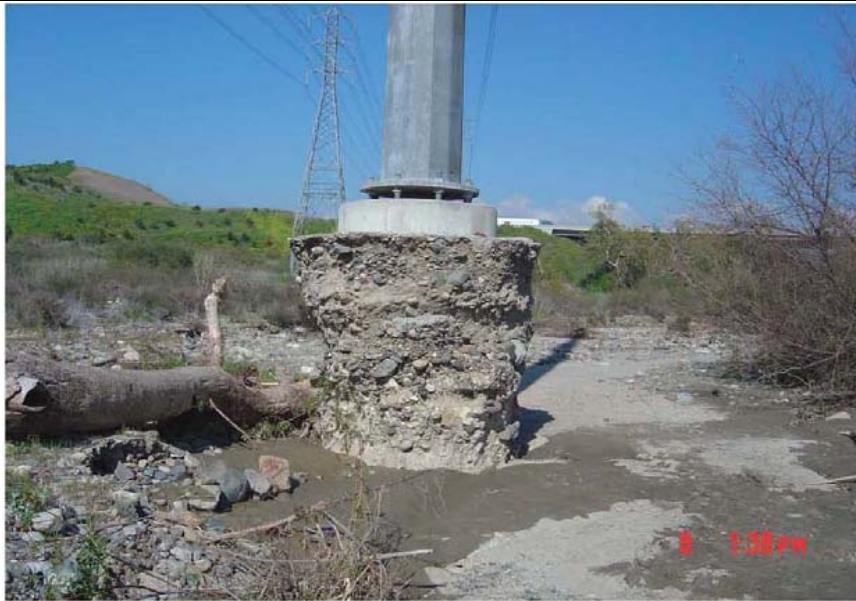
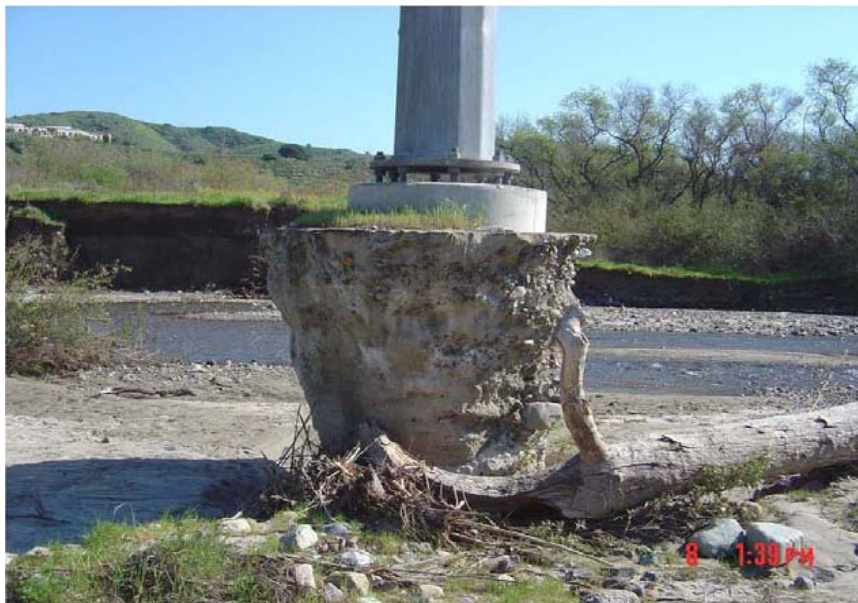
16

TSP M9-P5
Borrego-Chiquita 66kV T/L

Erosion

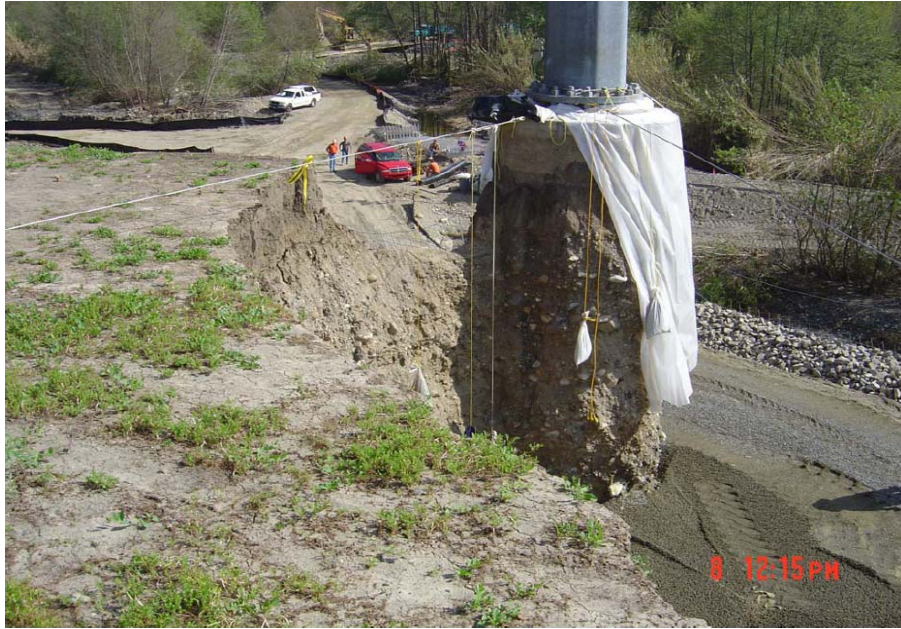
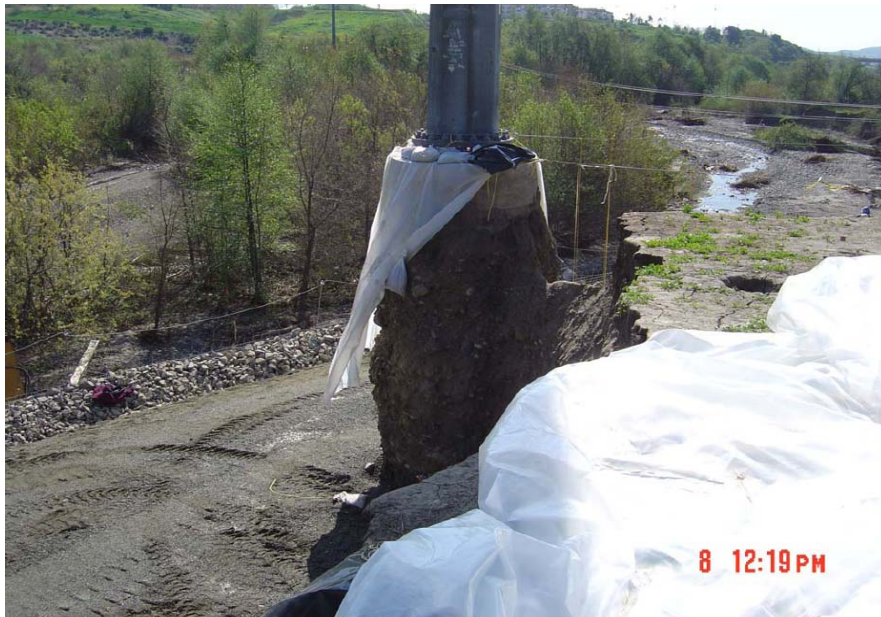
M8-P6 Borrego-Chiquita T/L

Erosion

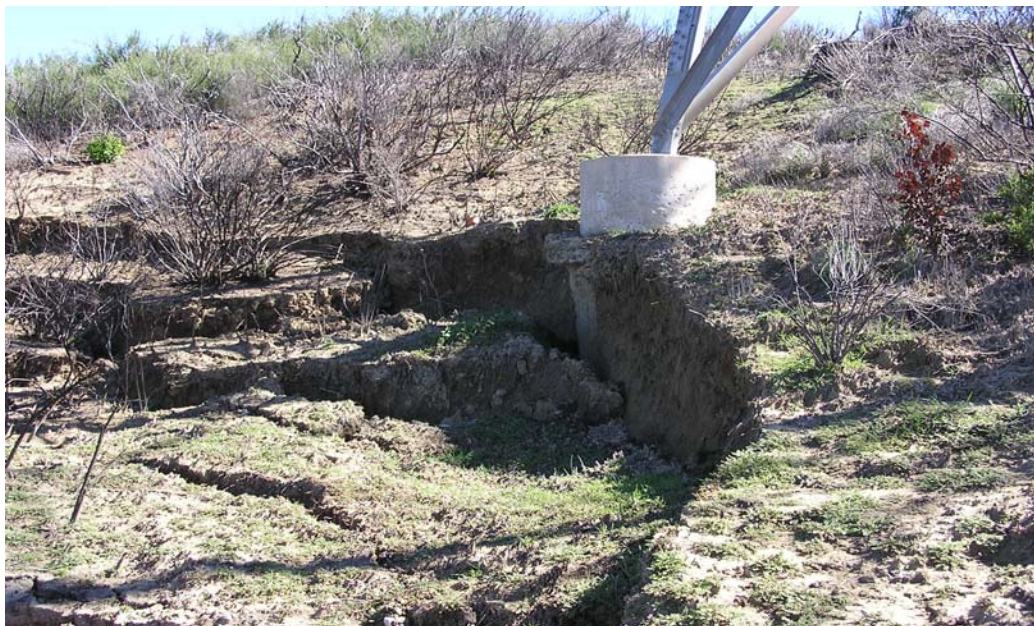
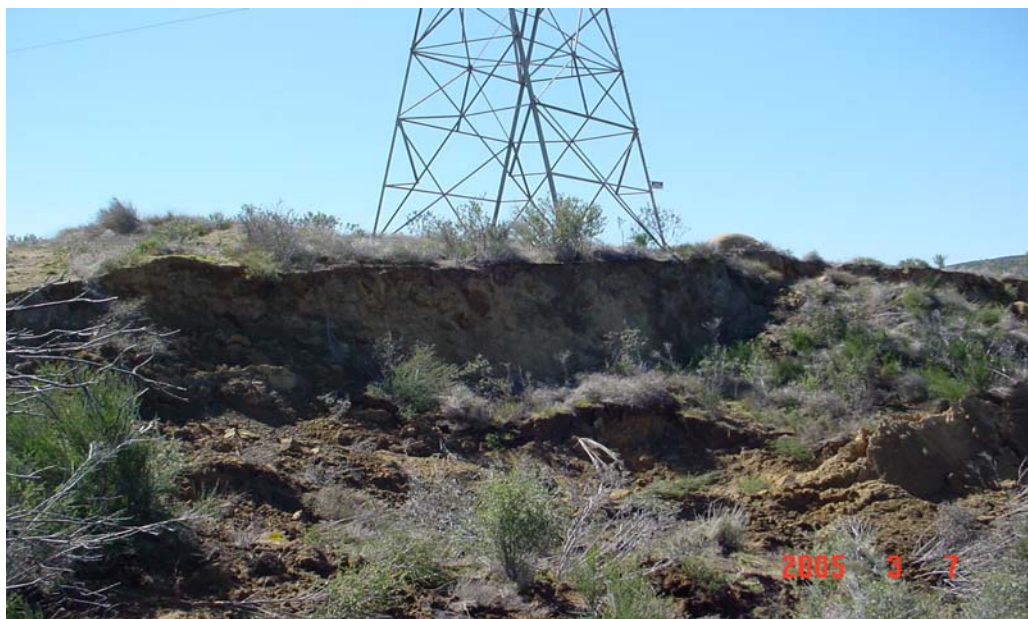
19

**Midway-Vincent 500KV T/L M76-T1
Rotational Slide**

Pardee-Pastoria M196-T4

Slope Instability

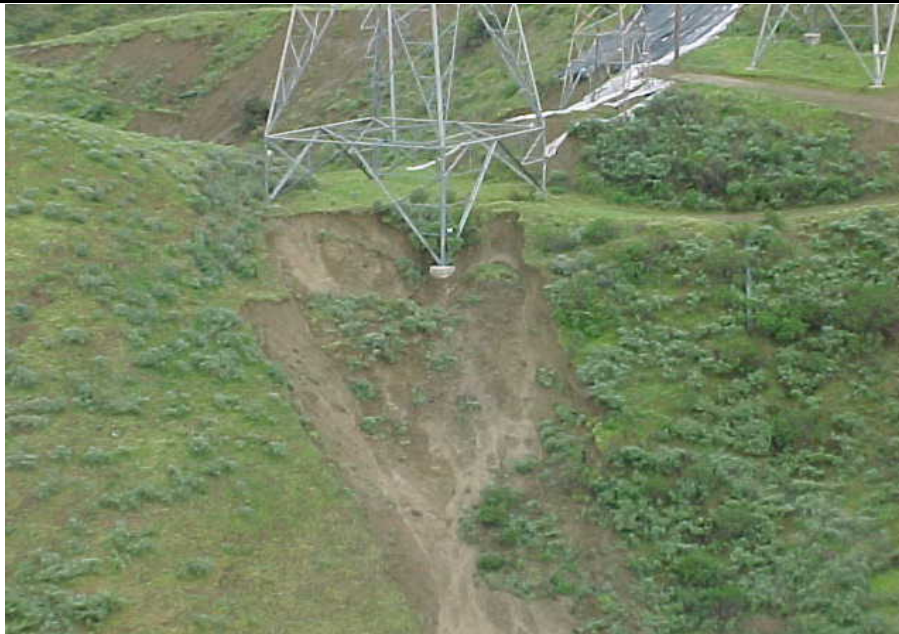
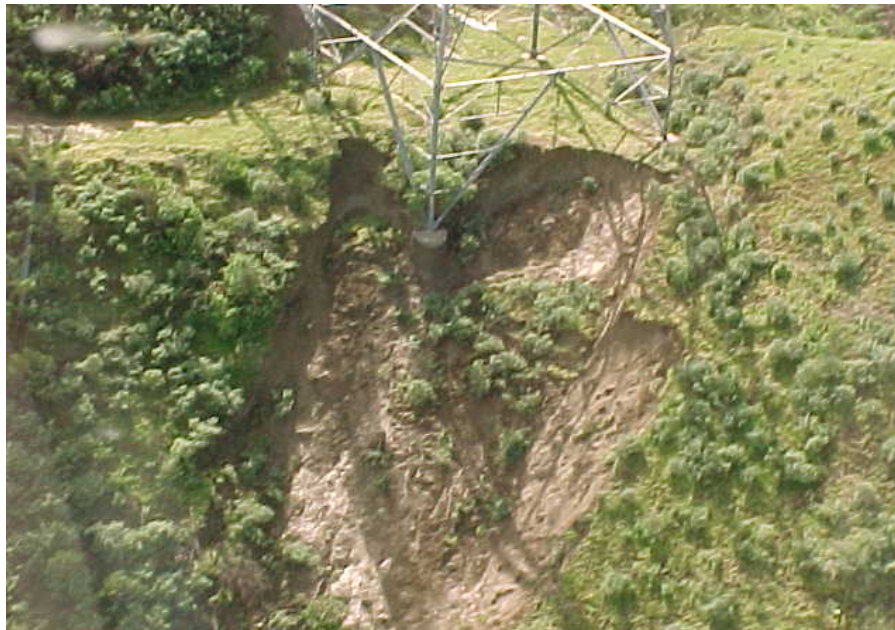
20

Moorpark-Pardee 220 kV

Slope Instability
