SDG&E SALT CREEK SUBSTATION PROJECT

CPUC MONITORING SUMMARY REPORT

January, 2017

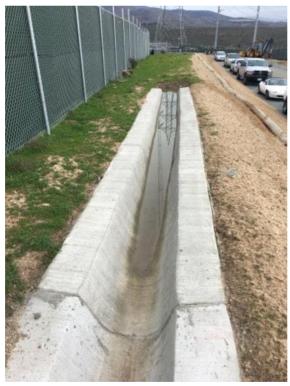
Caption Brow ditch with water along eastern boundary

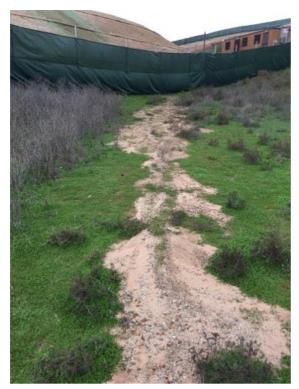
Caption Offsite erosion area, previously reported. Area of siltation grew by about 10-12 feet since original photo was taken.

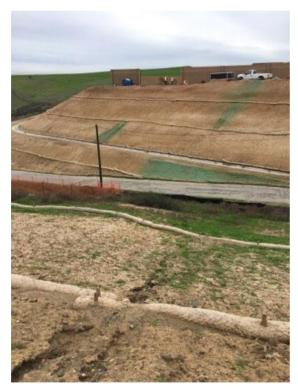
Caption Slope erosion on both slopes

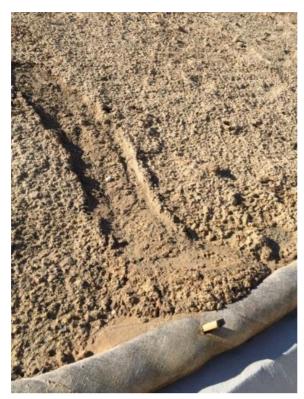
Caption Straw wattle compromised by soil buildup on NE slope by construction trailer.

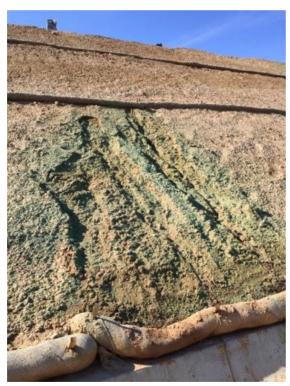
Caption Erosion rills on NE slope by construction trailer.

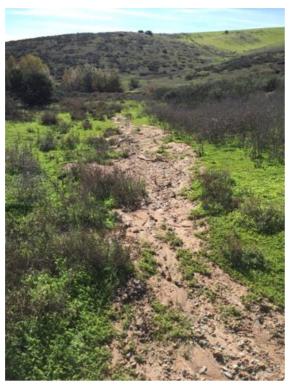
Caption Offsite erosion from drain outflow on south slope.

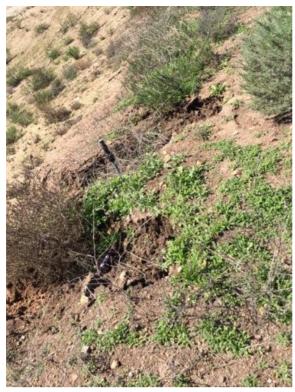
Two more erosion gullies have formed from offsite flows.

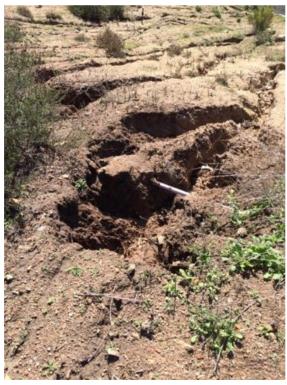
Erosion increasing from offsite flows.

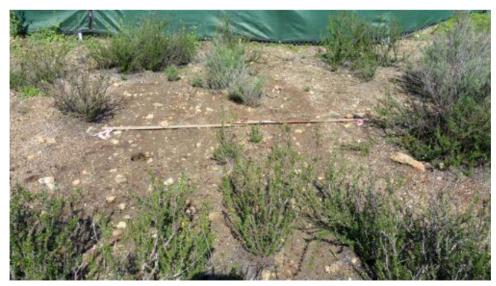
Caption Main rill exiting site unchanged by rain event.

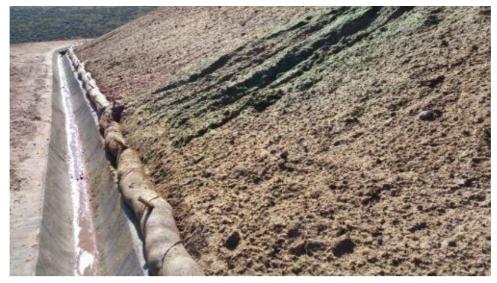
Caption Sediment removed from above straw wattle on east slope.

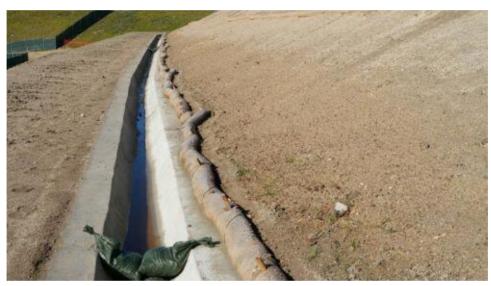
Caption Sediment buildup behind lowest row of fiber rolls on west slope was removed.

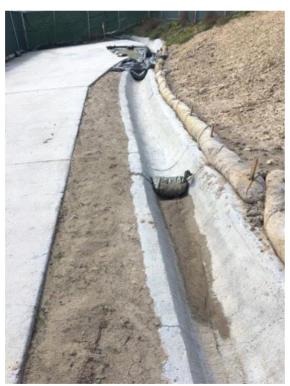
Caption Sediment near outfall should be removed before next storm.

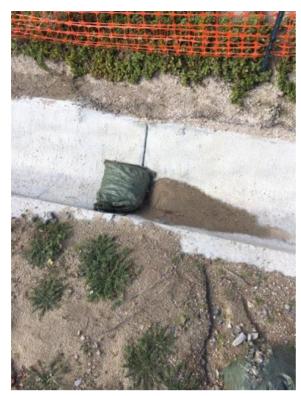
Sediment that needs to be removed

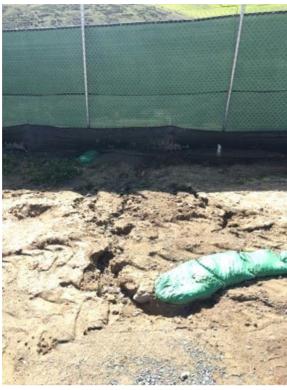
Caption Erosion near entrance, maintenance required

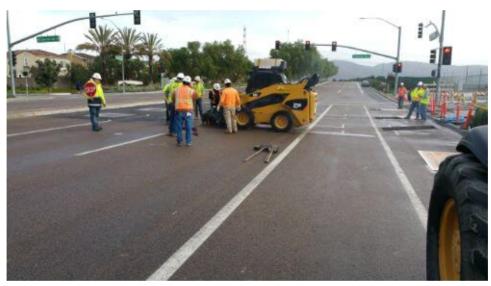
Caption Grinding pavement in Hunte Parkway for conduit trenches

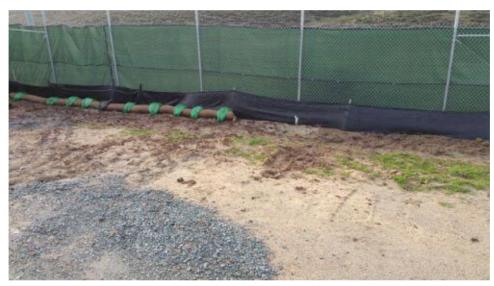
Caption Straw wattle in place at low point near entrance.

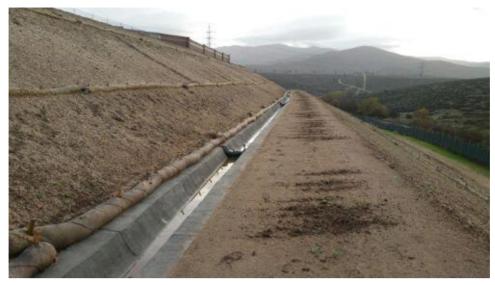
Caption West slope shows no further erosion.

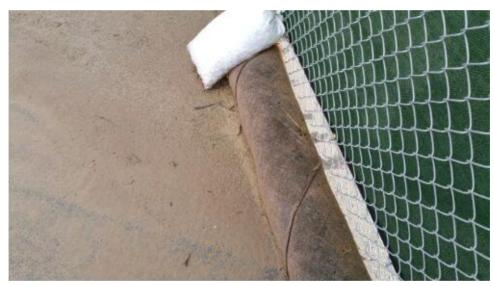
Caption Sediment at bottom of paved road detained onsite (note clean pavement beneath fence).

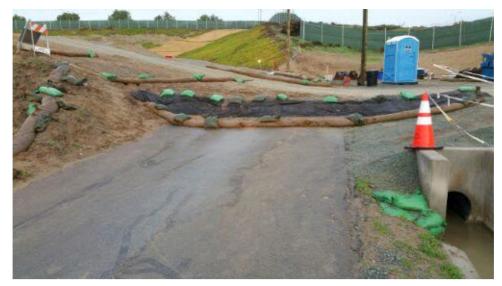
Caption Erosion control "burrito" with little sediment below it.

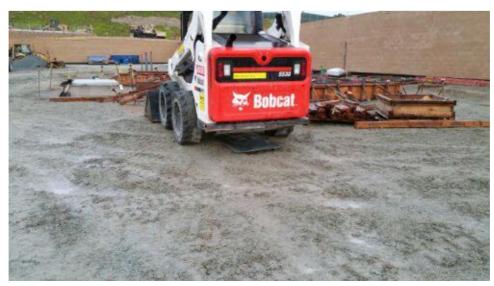
Caption Drip pan in place.

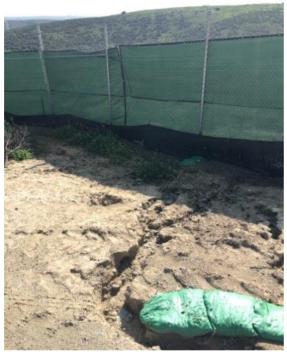
Caption Access road entry/silt fence that needs maintenance

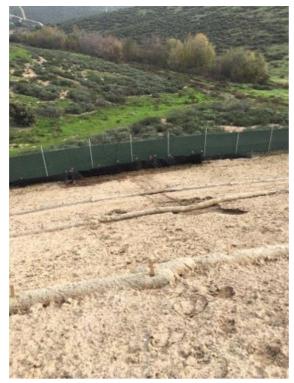
Caption New silt fence downslope of erosion area

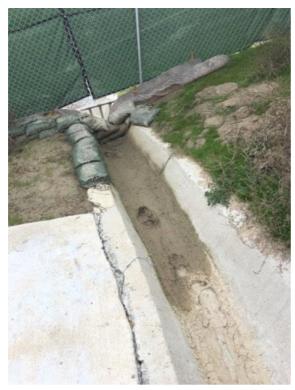
Caption Sediment that needs to be removed

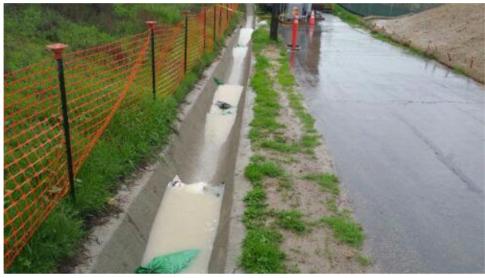
Caption Water flowing over gravel bags in brow ditch along sewer road (east part of site).

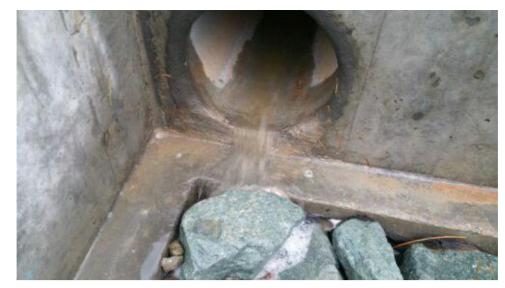
Caption Water flowing off-site from Line B (south side) appears to be within acceptable opacity.

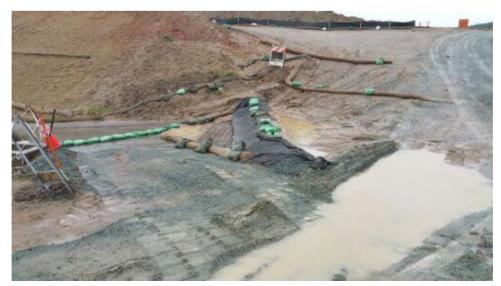
Caption BMP below largest disturbed area captured most sediment. Photo Attributes Capture Date/Time: Fri Jan 20 2017 09:47:13 GMT-0800 (PST) Coordinates: 32.619983, -116.948615

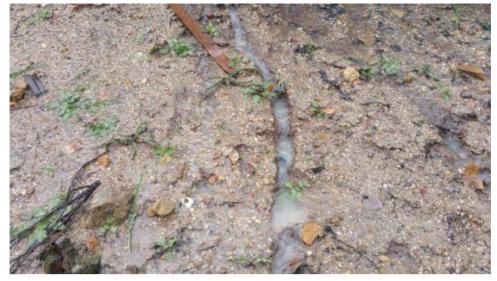
Caption Sediment-laden water running off-site down from spot where gravel bags were circumvented.

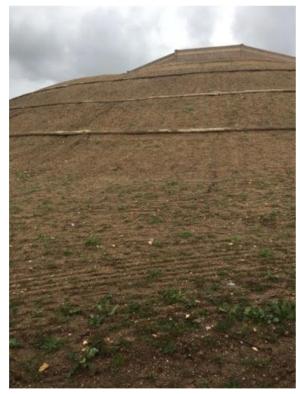
Caption Light BFM coverage

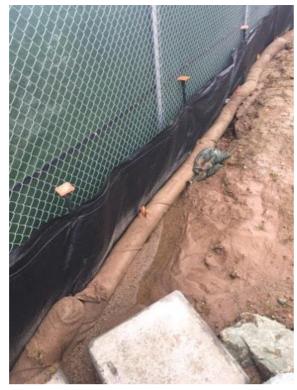
Flow going offsite from outfall area

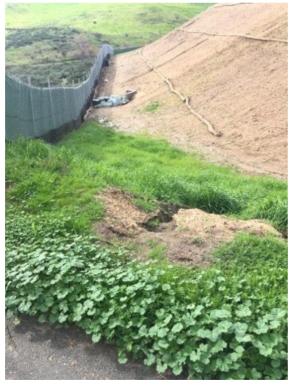
Erosion on road slope below construction trailer

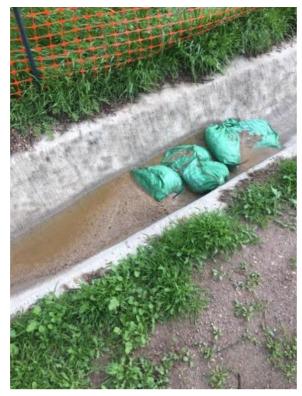
Sediment that needs to be removed

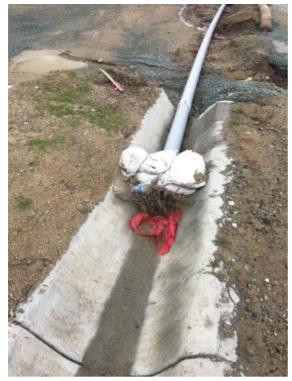
Caption Trash in brow ditch

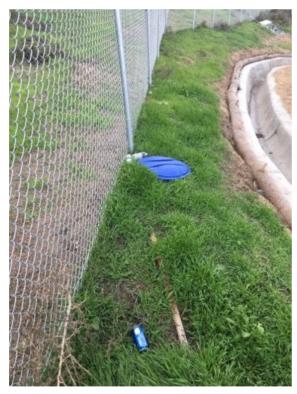
Caption Trash along eastern fence boundary

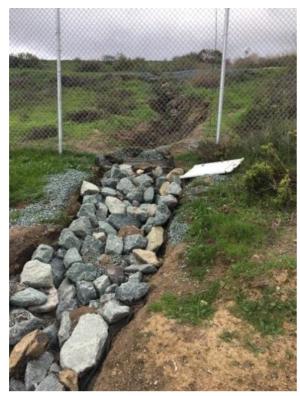
Caption Access road erosion area

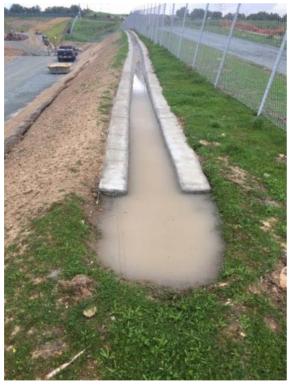
Caption Brow ditch with no outlet

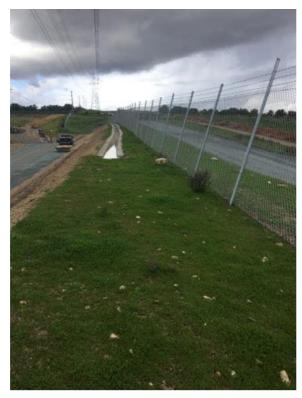
Perimeter fence without green screening

Perimeter fence needs to be repaired. Mesh screening on eastern boundary needs to be replaced.

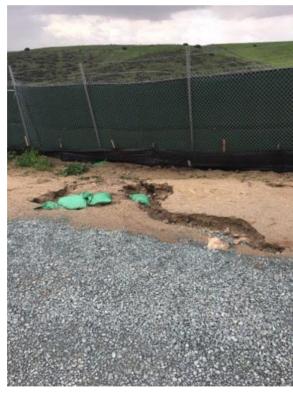
Site erosion along access road entrance

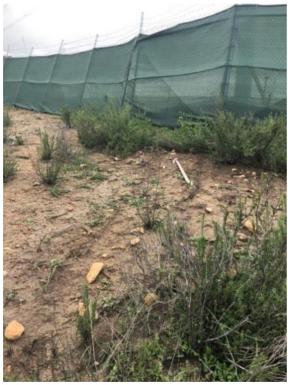
Offsite runoff and erosion

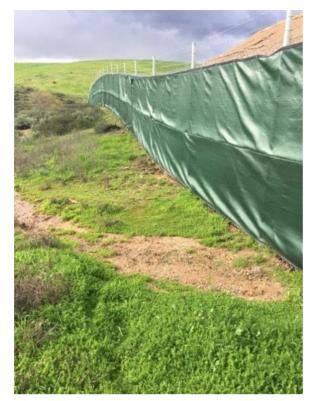
Secondary outfall - flow downstream is from western-most eroded area. No surface flow at the 2ndary outfall (foreground eroded area).

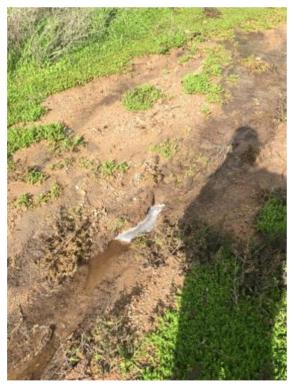
Possible water contaminant - secondary outfall area offsite.

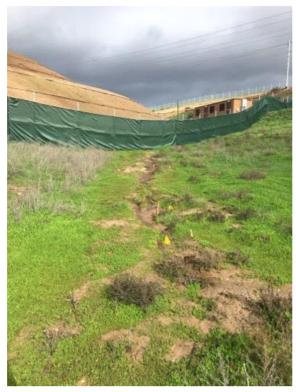
Secondary outfall with flowing water within small channel

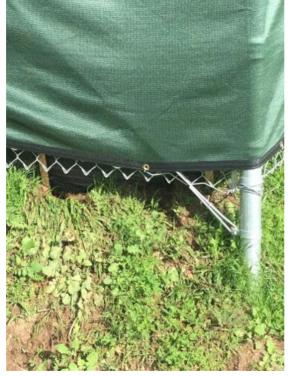
Water flow evidence - matted down grass and minor erosion

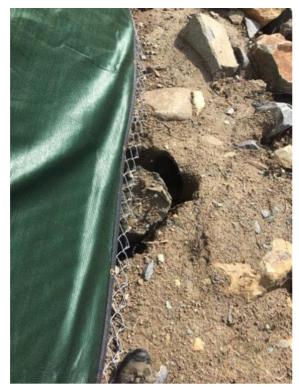
Caption Erosion at primary outfall area

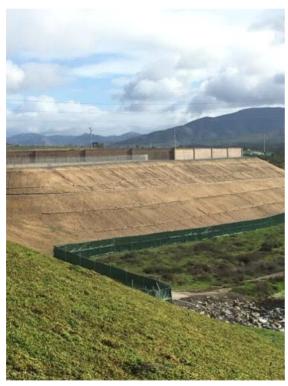
Caption Western slope with erosion

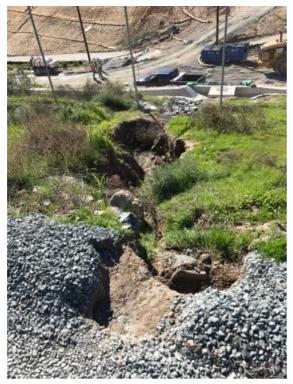
Caption Sections of construction fencing along upper transmission access road needing repair

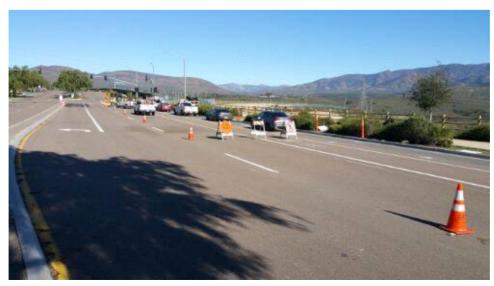
Caption Screening fence along east access road has been removed after wind caused damage to chain link fence.

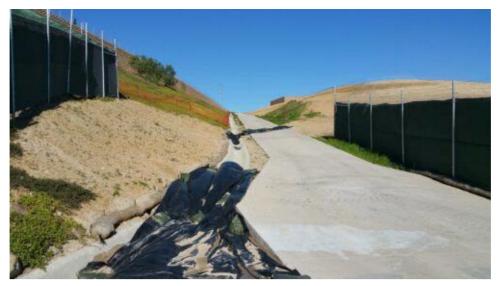
Silt to top of gravel bags at bottom of main brow ditch, indicating that they may have been overtopped. Caption

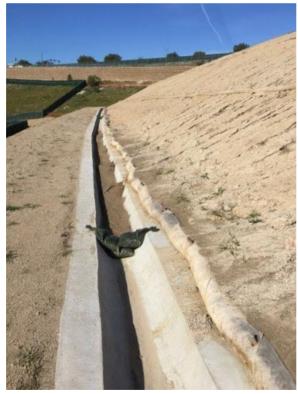
Lower fiber roll on western slope needs maintenance

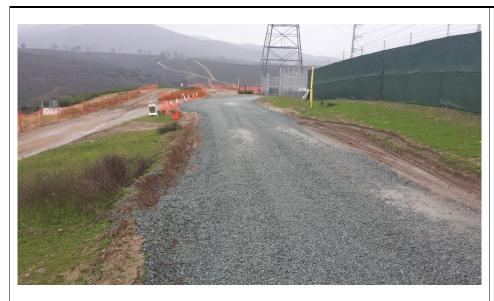
Photograph 4:

Two sets of truck-tire tracks were observed going outside the limits of the western-most of the two transmission access roads near the Project east gate and were recorded as a Level 2: Minor Problem on January 9, 2017.

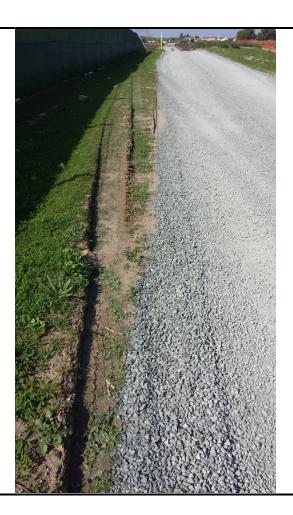
Photograph 4:

A haul truck drove approximately 4feet outside the limits of the western-most of the two transmission access roads in order to pass on an on-coming vehicle. The incident was recorded as a Level 2: Minor Problem on January 18, 2017.

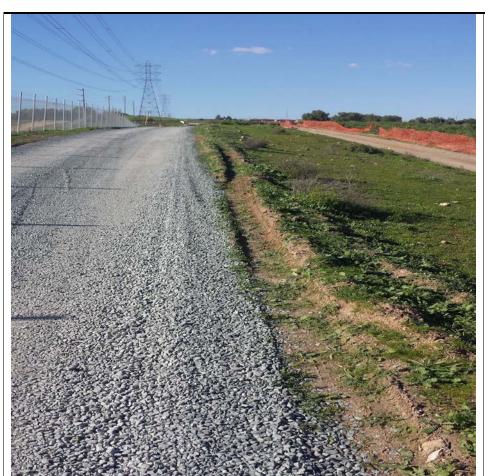
Photograph 4:

Truck tire tracks were observed outside the boundaries of the west transmission access road (facing northwest). The incident was recorded as a Level 2: Minor Problem on January 26, 2017.
